Slope Stability in Road Construction

SLOPE STABILITY IN ROAD CONSTRUCTION^x

A GUIDE TO THE CONSTRUCTION OF STABLE ROADS IN WESTERN OREGON AND NORTHERN CALIFORNIA

1976

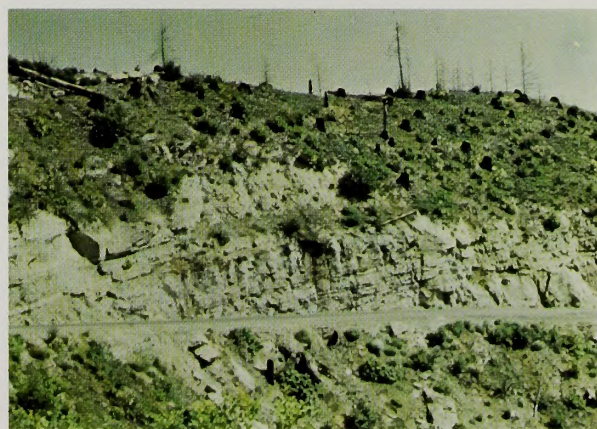
Figure 4. Tyee Formation showing massive beds

The Tyee occupies the greatest area of any formation in western Oregon (see Figure 2). The Tyee has massive beds, each of which grades upward from sandstone to siltstone. The colors range from medium-gray to bluish-gray on fresh surfaces and may appear tan to gray on weathered surfaces (Figures 3 and 4).

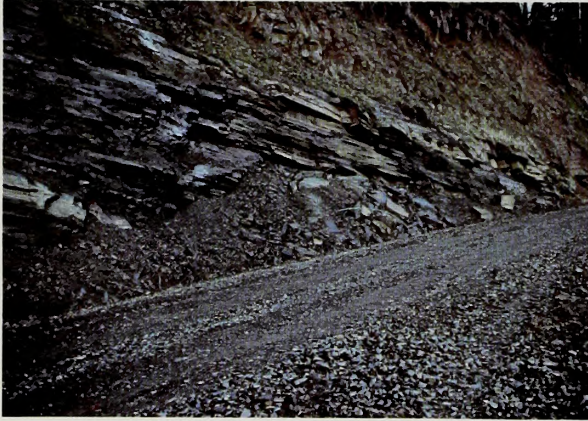
Figure 5. Thin beds of mudstone in the Yamhill formation

The Yamhill Formation contains gray to greenish-gray massive sandstone beds with thinner layers of medium-gray to dark-gray mudstone, siltstone, or shale (Figure 5). The Yamhill Formation is found in two general areas (Figure 2), one west of Salem and another northeast of Coos Bay.

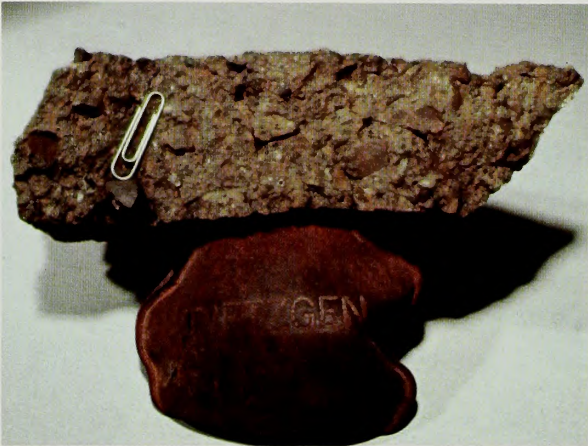
Figure 6. Pebbly conglomerate from the Umpqua formation

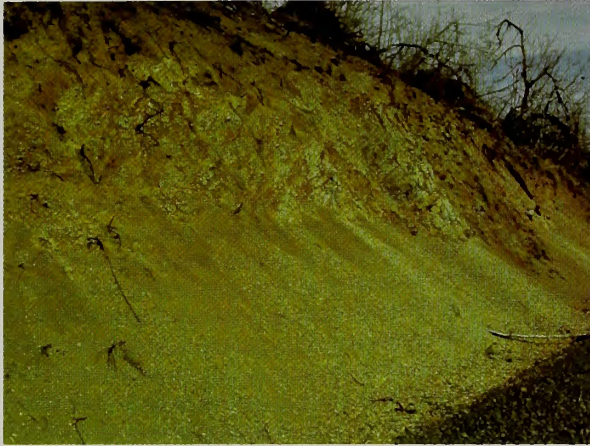
Figure 8. Siltstone material of the Nestucca Formation

The Nestucca Formation covers a large area northwest of Salem and is composed of interbedded siltstone (Figures 7 and 8), claystone, and sandstone. In many places the Nestucca Formation is interbedded with basalt flows.

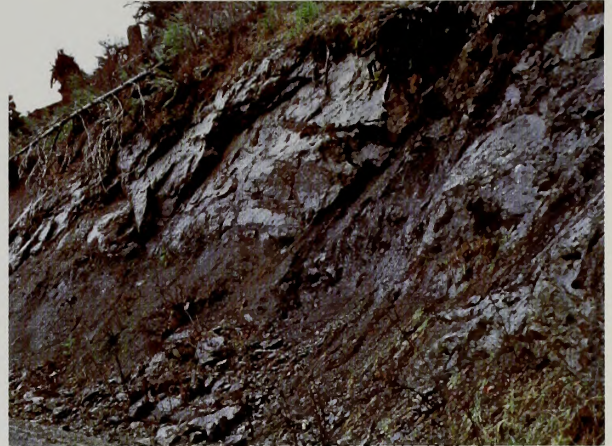
Figure 9. The Otter Point formation contains sandstone, mudstone and shale.

The appearance of the Otter Point Formation, and associated formations with similar characteristics, is that of highly sheared, tan, dark-gray or black sandstone with interstratified thin mudstone, minor conglomerate, and volcanic material (Figure 9). This material occurs in small areas from Myrtle Creek (south of Roseburg) on west to a large block along the southwest Oregon coast.

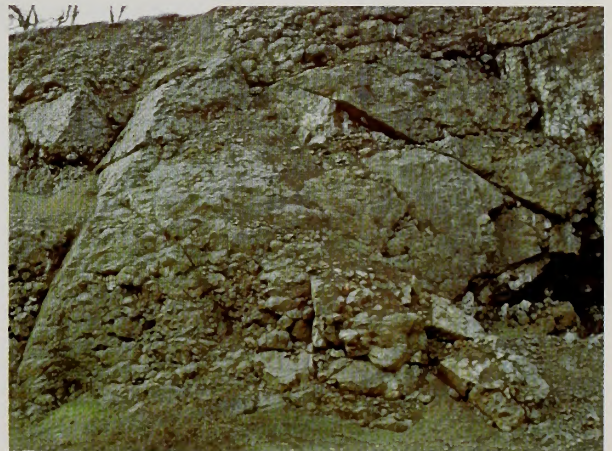
Figure 10. Rounded shapes of pillow lava

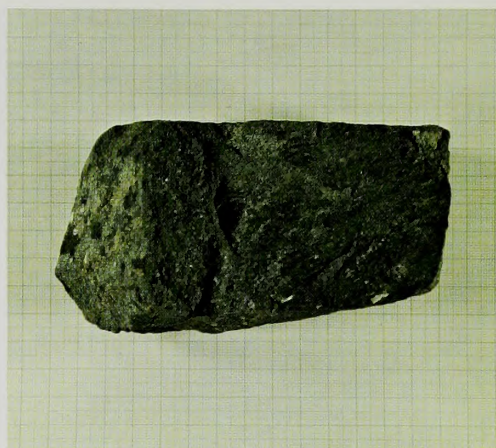
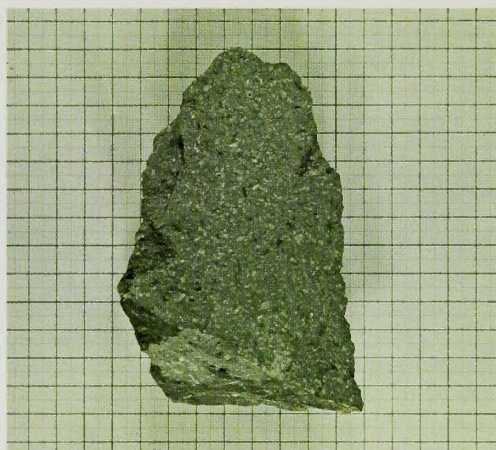
DIORITE

BASALT

GABBRO

ANDESITE

Figure 11. Four common intrusive and extrusive igneous rocks

Photographs of four common extrusive and intrusive rocks are shown in Figure 11.

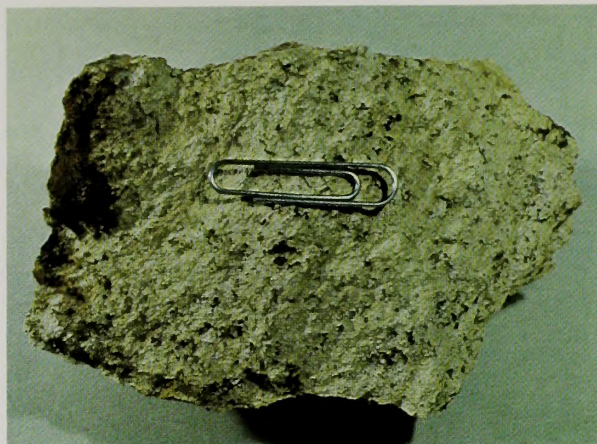
Figure 13. Tuff composed of smaller particles than breccia.

photograph of this material is shown in Figure 13.

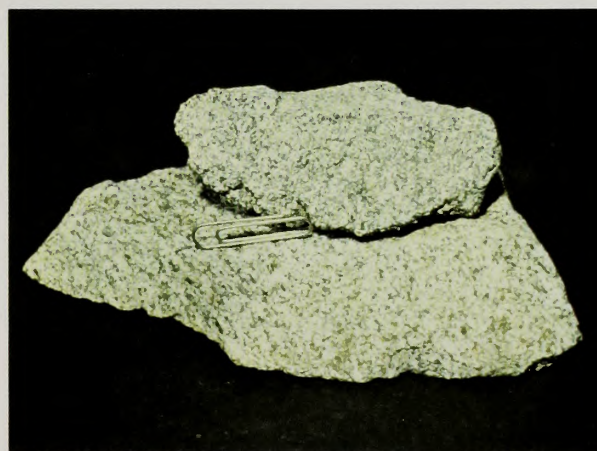
Figure 15. Granitoid or “granite-like” rocks

rocks (Figure 15). Weathered granitoid rock tends to crumble easily into a coarse “sand” as the weathering process degrades the grain-to-grain contact that holds the large crystals together. Granitoid rocks are found in the Klamath Mountains and in isolated spots in the Cascades (Figure 2).

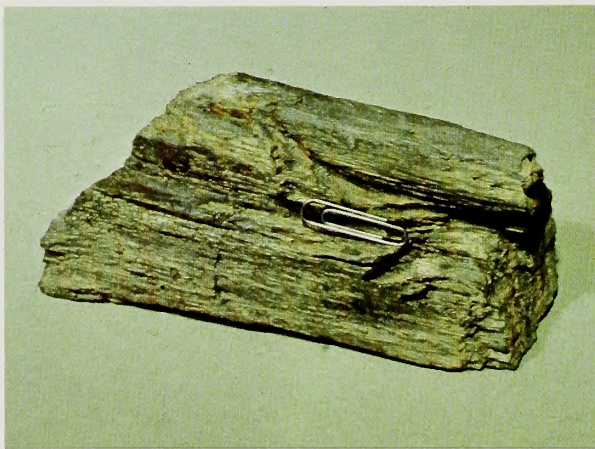
Figure 16. Colebrook schist showing the platy appearance.

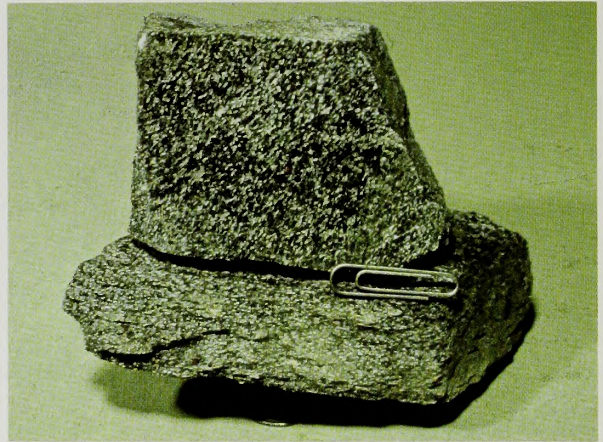
Figure 17. Schist from Evans Creek near Medford, Oregon.

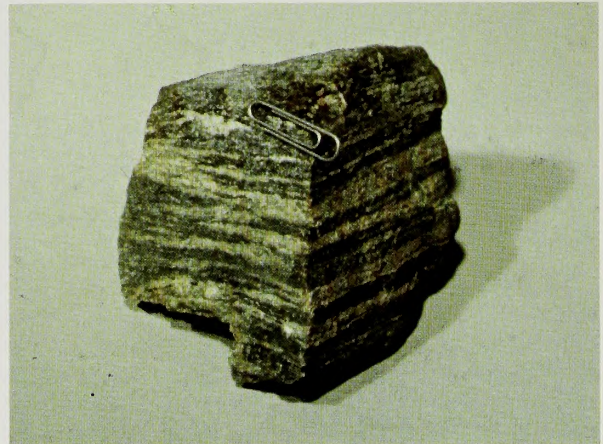
Figure 18. Gneiss has relatively thick bands of colored material.

Metamorphic rocks are formed from any existing rock by changes caused by heat, pressure, and/or chemical alteration. Either the pressure of extremely thick layers of sedimentary rock or the heat from large bodies of intrusive igneous rocks can alter the texture of the surrounding rock with an accompanying rearrangement of elements into different minerals. Ground water can also carry chemicals into or away from the area where metamorphism is taking place. Limestone may be metamorphosed into marble; sandstone into quartzite; and mudstone into *shale* and then into *slate*. Further metamorphism of slate produces *phyllite*, a rock whose color ranges from light-green through gray to black. Freshly broken surfaces of phyllite show a silky sheen. *Schist* is one of the most abundant rocks produced by regional metamorphism. There are many varieties of schist produced from igneous, sedimentary, or metamorphic rocks. Schists are dominated by clearly visible flakes of platy minerals such as mica, talc, or hematite (Figures 16 and 17). Metamorphism of other materials, commonly granitoid rocks, may produce *gneiss* (pronounced “nice”), which is a relatively coarse-grained rock with parallel layers of light and dark minerals (Figure 18).

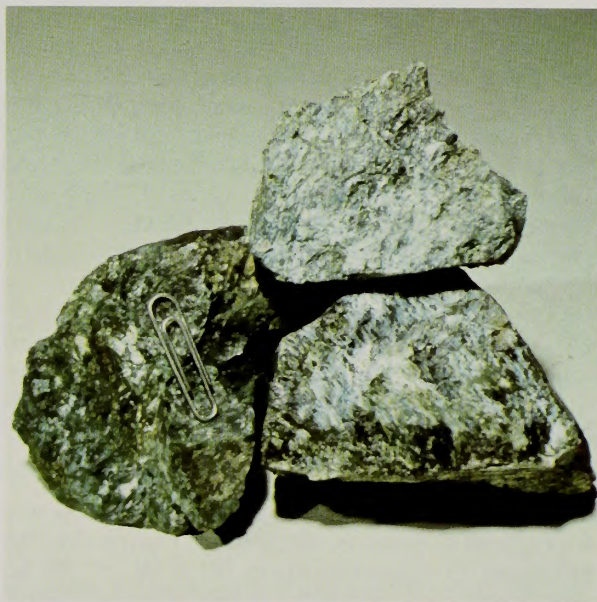
Figure 19. Serpentine may be black, bluish, or yellow-green.

The color of serpentine ranges from yellow-green, bluish-green, or olive-green to almost black (Figure 19). Serpentine occurs within the ultramafic rocks as described above, but also as intrusions within non-ultramafic rocks. These intrusions may be in the form of thin veins or extensive masses. The thin belts or streaks of serpentine are frequently oriented southwest to northeast in the northern Klamath Mountains and along the southwest coast of Oregon. Farther south in California, these belts of serpentine are oriented northwest to southeast.

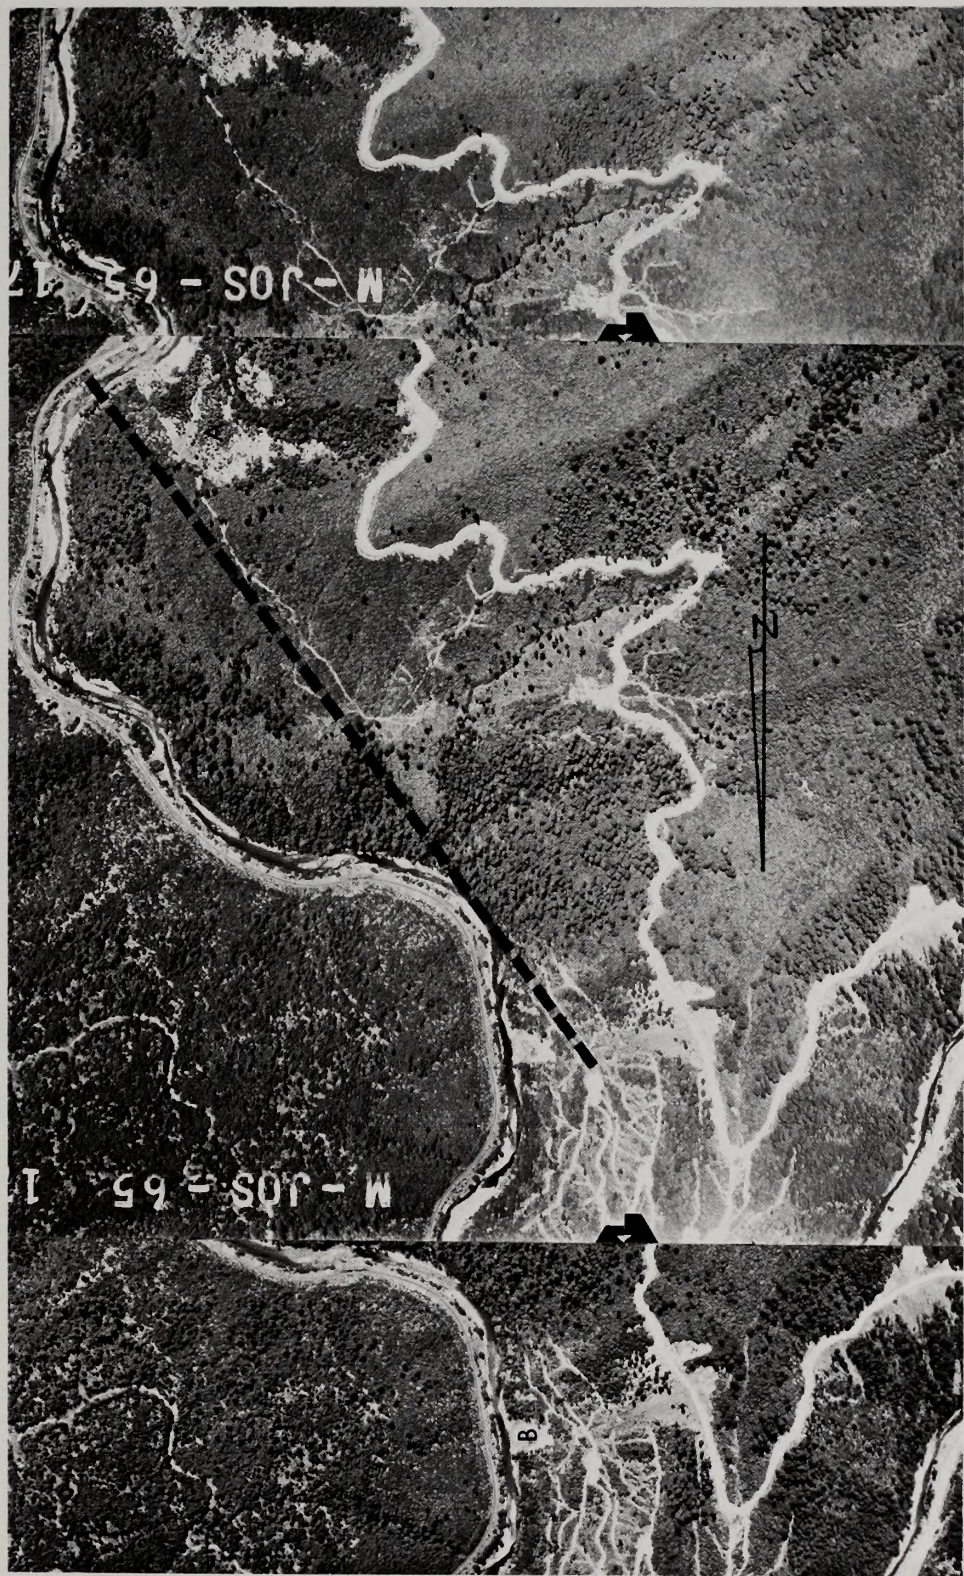
Figure 22. Stereogram of a possible fault zone. The location of the fault is indicated by the dashed line through the low saddle between the large, older slump at A and the newer slope failure at B.

Aerial photographs should be carefully examined for possible fault zones when neither geologic maps nor topographic maps offer any clues. Figure 22 is a stereogram of a portion of Cow Creek, south-southwest of Roseburg, Oregon. A possible fault zone is indicated on the stereogram; note that it passes through several saddles and begins and ends in Cow Creek. Also note the large, old slide at A and the newer slide at B. These photographs were taken in 1965; since then a highway has been constructed along Cow Creek on the bank across from the railroad. The slide at B has enlarged, has been actively moving, and has buckled the highway at the base of the slide. Further evidence of a fault zone through this area is shown in the photograph of a rock from the slide at B (Figure 23). The important feature is the slick, shiny surface caused by the intense heat developed by friction on sliding surfaces within the fault zone.

cubic yard Camp Creek slide in Coos Bay of 1970 (Figure 37). The Cow Creek slide shown at point B in Figure 22 is a rockslide that occurred in the Dothan formation along a fault zone. Figure 38 shows the deposition of fractured rock from this slide and the displacement of the road, both vertically and laterally. This particular slide has a potential for further movement as evidenced by cracks in the slopes parallel to the margin of the slide. Road locations through areas with a potential for rockslides should be examined by specialists who can evaluate the competence of the rock and determine the dip of the bedding planes.

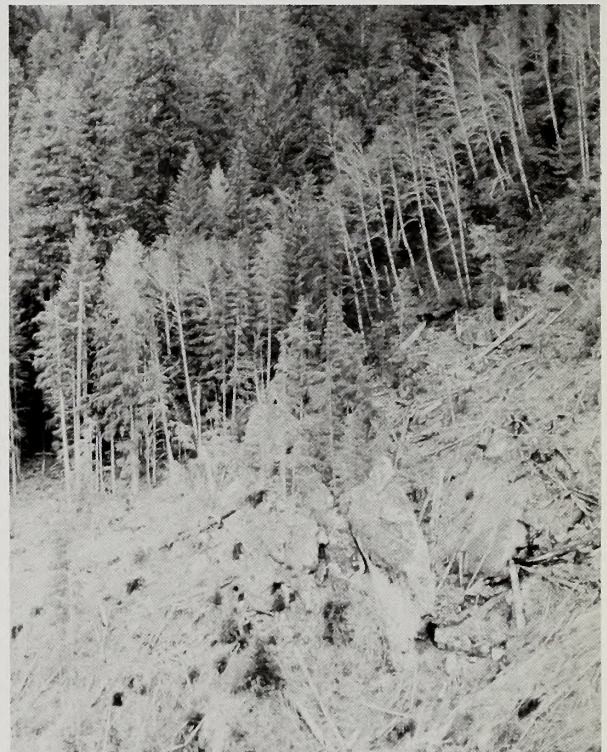
Figure 25. Photograph of the fault zone shown at point A on Figure 24.

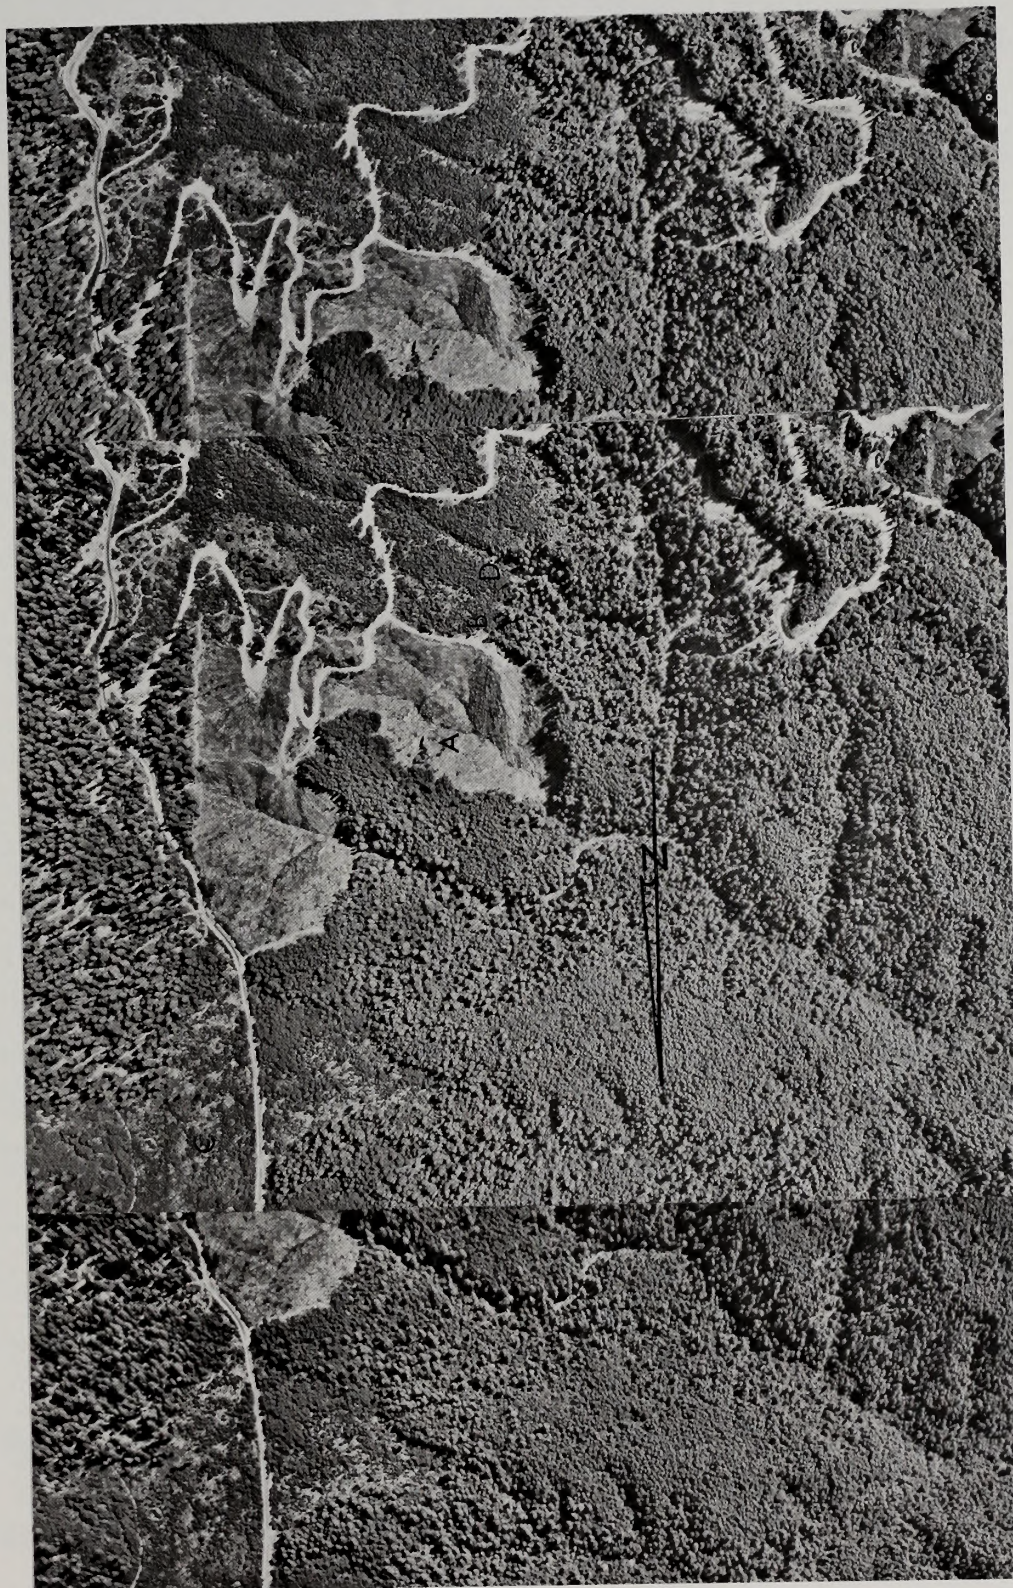
Figure 24. Fractured and up-tilted rocks are shown at point A. A ground photo of this feature photographed from point B is shown in Figure 25. Changes in the slope of the ground at points C and D indicate a possible fault zone through these points.

Field personnel should be alert for on-the-ground evidence of faulting when neither geologic maps nor topographic maps provide definite clues to the location of faults. Figure 24 is a stereogram of a suspected fault zone. Topographic maps of this area do not show any definite indication of a fault zone. Timber has been harvested from several of the small drainages and fractured and uptilted rock may be seen at Point A in Figure 24. Figure 25 shows a photo of Point A taken from the spur road at B. This direct evidence of faulting probably could not have been seen on aerial photos before timber harvest, but if field personnel observe such evidence during road reconnaissance then an intensive investigation should be started. In this case, the faulting at A together with the topographic clues at C and D indicate a fault zone that extends through C and D.

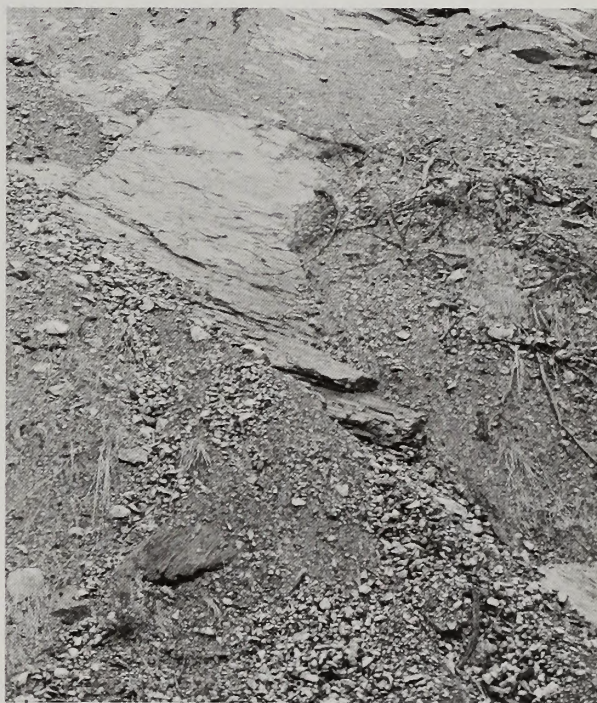
Figure 27. This figure shows how easily soil can slide into a road when the bedding planes of the rock slope toward the road.

There are many locations where sedimentary or metamorphic rocks have been warped or tilted and the bedding planes may be steeply sloped. If a road is planned for such an area, it is important to determine the slope of the bedding planes relative to the ground slope. In areas where bedding planes are approximately parallel to the slope of the sidehill, road excavation may remove enough support to allow large chunks of rock and soil to slide into the road (Figure 27). If preliminary surveys reveal that these conditions exist, then the route may need to be changed to the opposite side of the drainage or ridge where the bedding planes slope into the hillside.

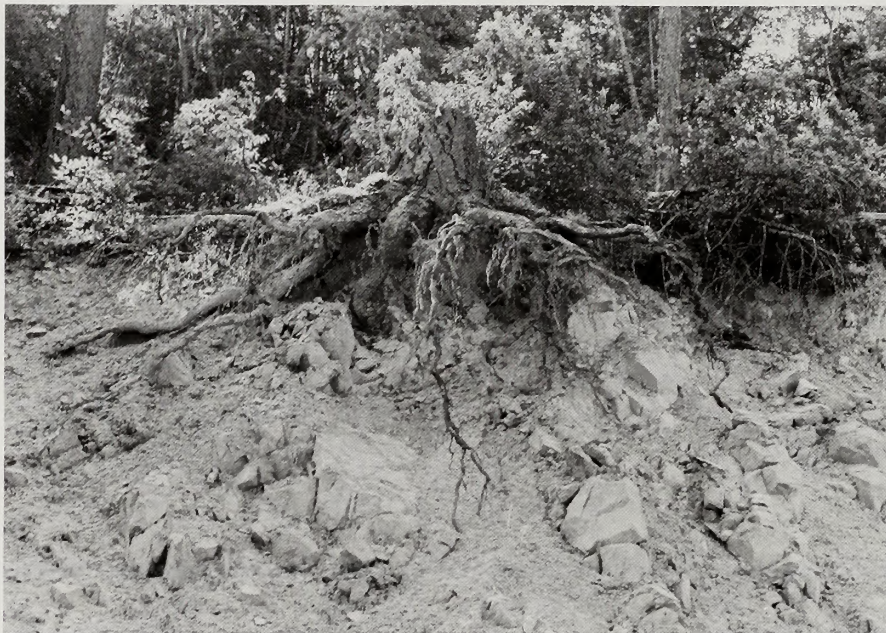
Figure 33. This illustrates the manner in which tree roots act to hold shallow soil to fractured bedrock.

The effect of tree root strength on slope stability is not fully understood and is the subject of studies by government agencies and various universities. Preliminary results of these studies indicate that under certain conditions living tree roots help maintain slope stability. Reports by the Forest Service from southeast Alaska indicate that the number of landslides from cut-over areas increases within 3 to 5 years after logging. This increase is attributed to a reduction in soil shear strength caused by the decay of tree roots following logging. The presence of living tree roots to anchor shallow soils on steep slopes to fractures in the underlying rock (Figure 33)

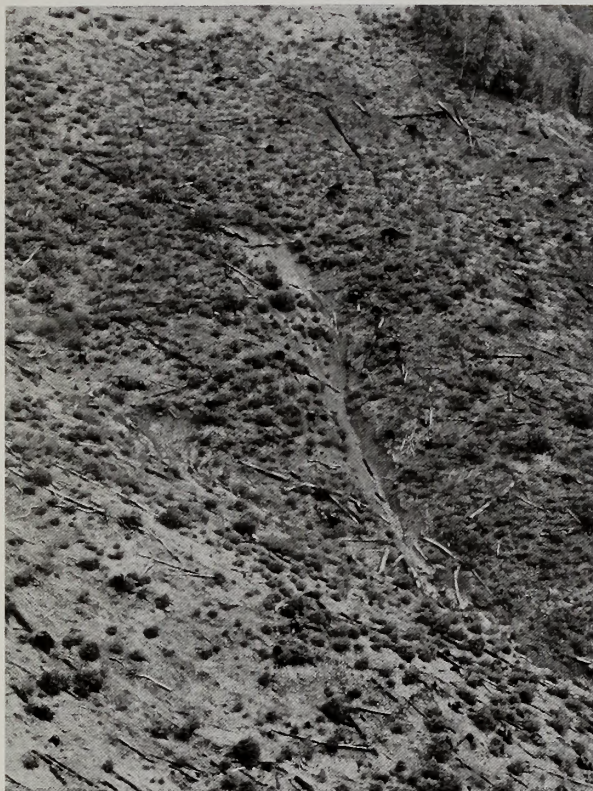
Figure 34

These photographs show shallow landslides that originate on clearcut areas. They often occur in small drainages where ground water may accumulate.

Figures 34 and 35 show typical slope failures that frequently originate within clearcut areas in shallow depressions on steep side slopes. Figure 36 is a stereogram that shows a number of failures on clearcut slopes that have not been roaded. All studies indicate that if the soils,

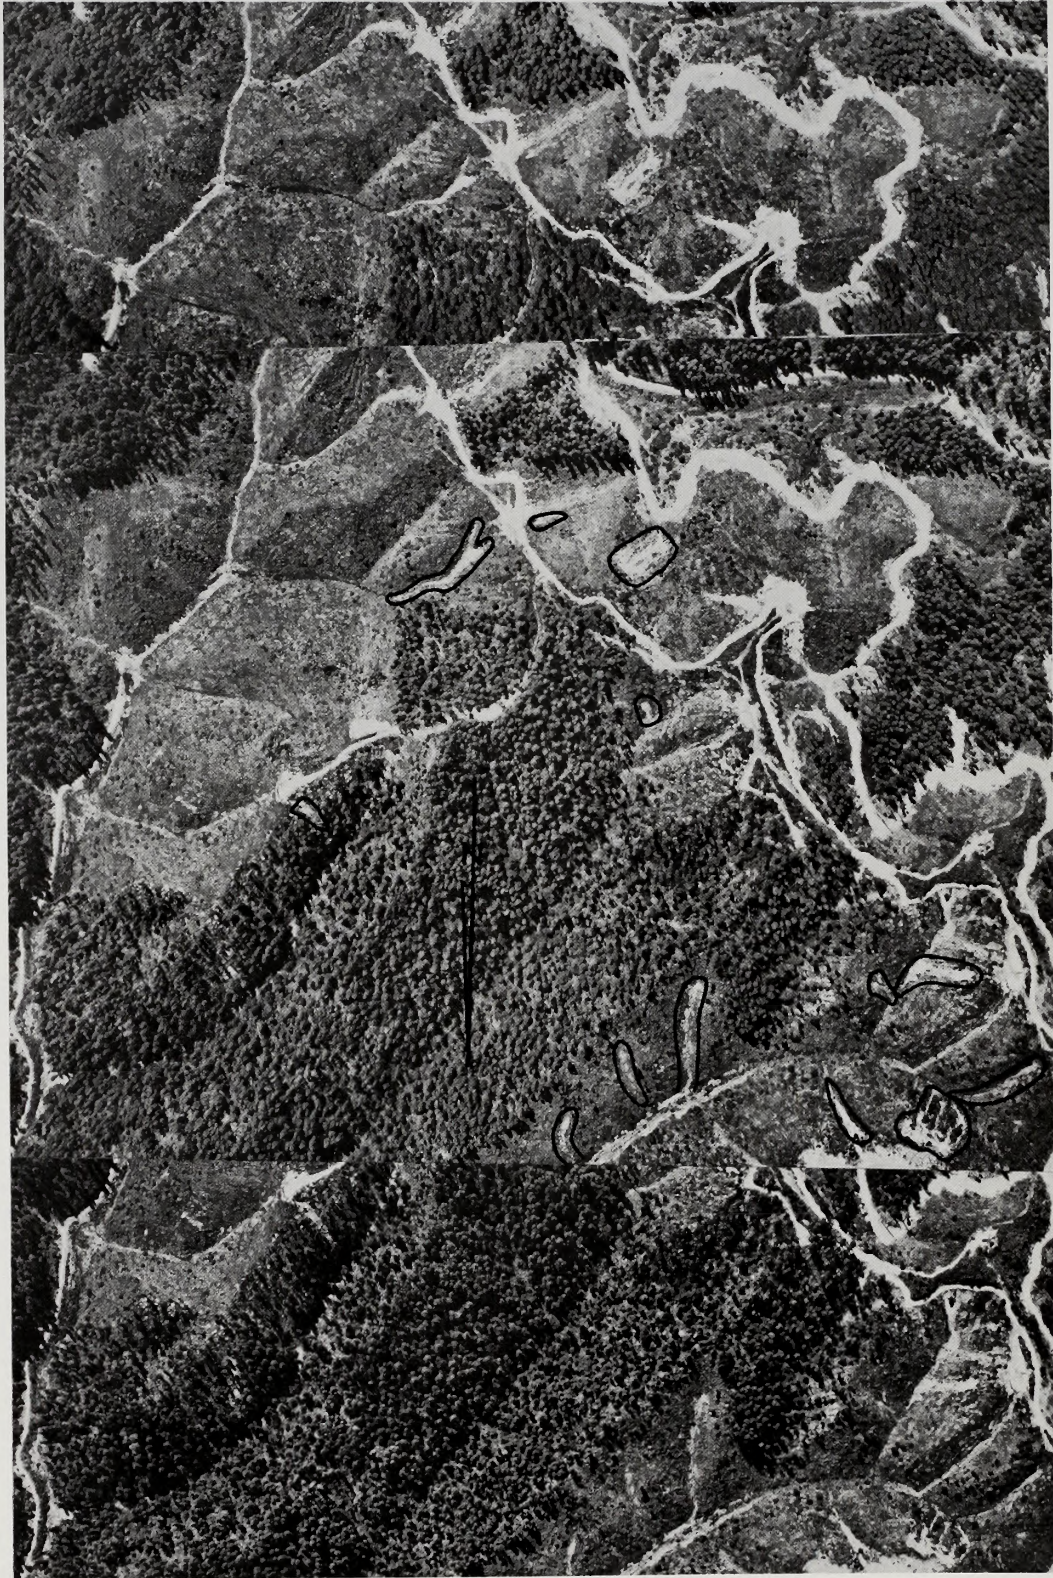
Figure 36. This stereogram shows slope failures that have originated on clearcut areas. The failures outlined in black are not associated with roads.

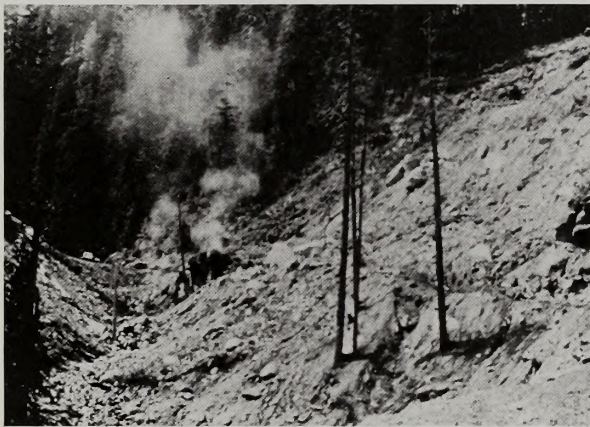
Figure 37. A rockslide in bedded sedimentary material

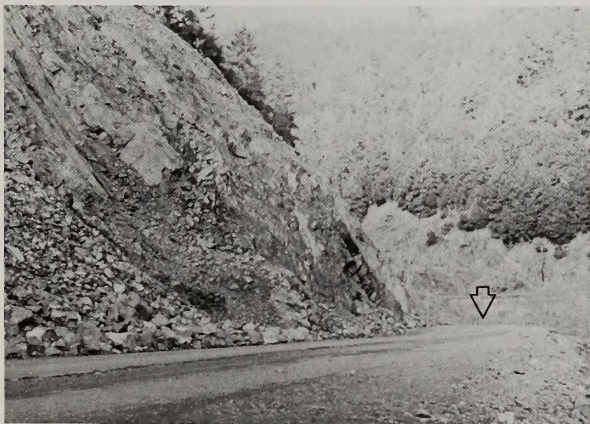
Figure 38. A photograph of the rockslide illustrated at point B in Figure 22. Note how the shifting rock is lifting the road (arrow) and moving it to the right towards Cow Creek.

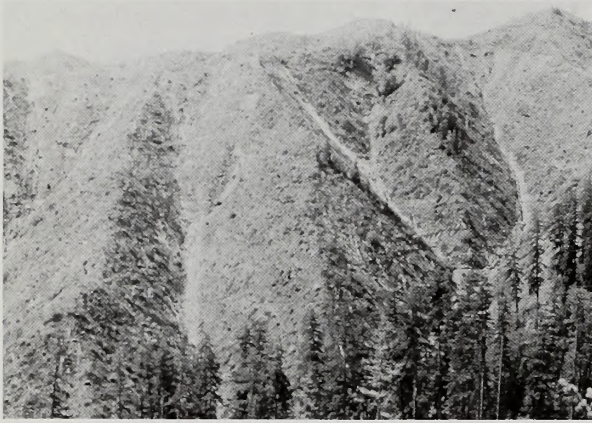
Figure 39.

These photographs illustrate debris avalanches that are common in shallow soils on steep slopes.

These two closely related types of slope failures usually originate on shallow soils relatively low in clay content on slopes over 65 percent (Figures 39 and 40). In southeast Alaska, the Forest Service has found that debris avalanches develop on slopes greater than 65 percent on shallow, gravelly soils and that this type of slope failure is especially frequent on slopes over 75 percent (Swanston, 1969 and 1970). An excellent description of debris avalanches and flows is given in Bailey, parts of which are quoted below:

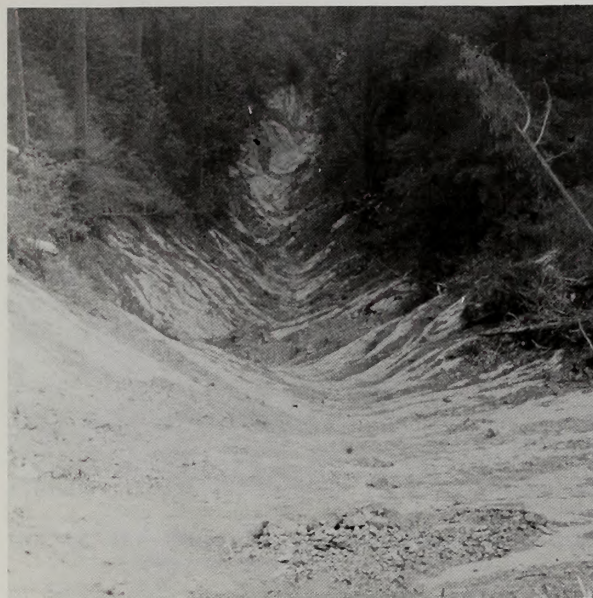
Figure 41. Frequent debris avalanches may create round-bottomed chutes in the bedrock.

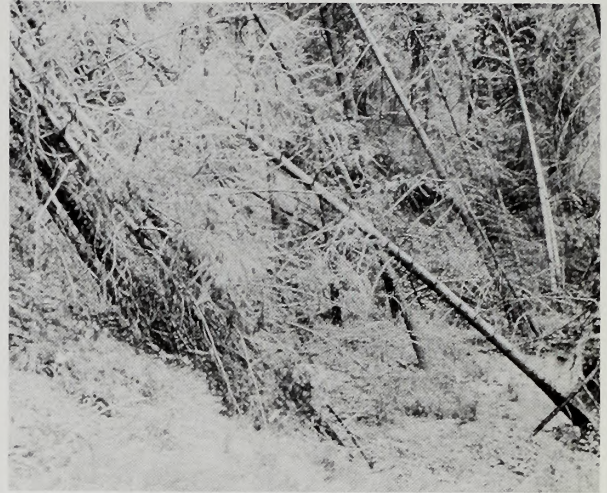
Figure 44. Backward rotation of a slump block as it starts its downslope movement to the right.

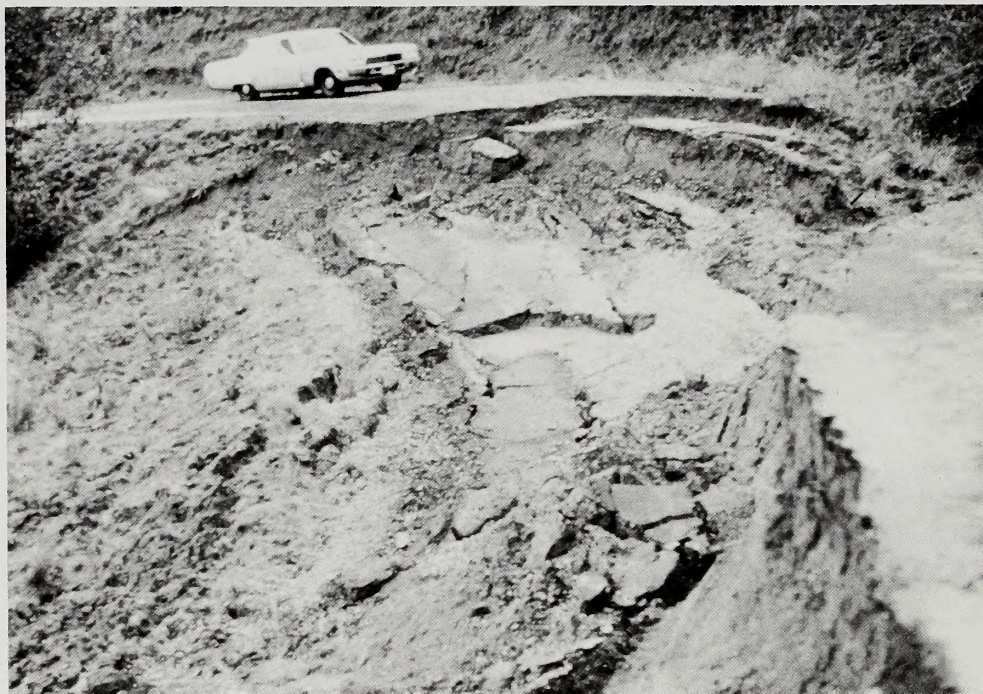
Figure 50. A failure of the foundation material under a compacted fill. Note how the soft underlying material was squeezed out allowing the fill to sink.

the material, reduces the pore space, and thereby reduces the adverse effect of ground water. The foundation material under the proposed fill should be evaluated as part of the design process to determine if this material will support a compacted fill without failure. Figure 50 shows a foundation failure of deeply weathered, very wet material of the Otter Point Formation beneath a compacted fill. Roads may

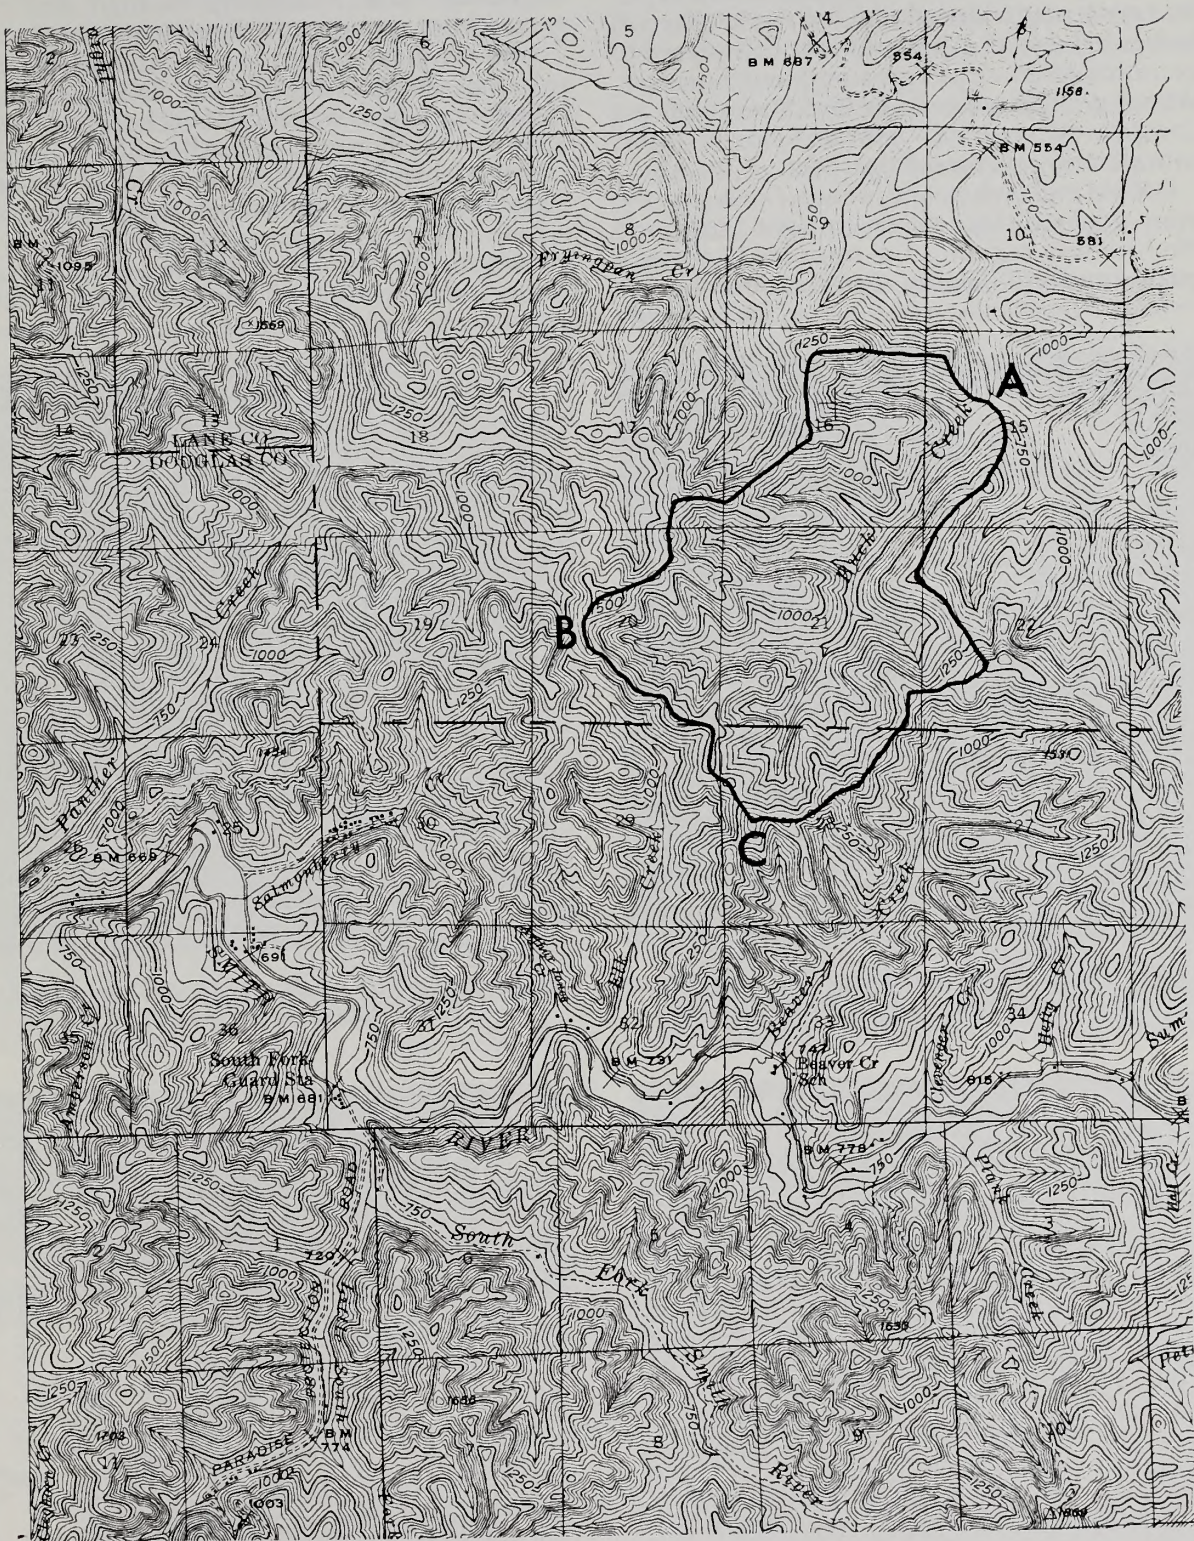
Figure 53. A topographic map of the steep terrain with sandstone bedrock where debris avalanches are the most common type of slope failure. The basin outlined in black is shown in the block diagram in Figure 52. Points A, B, and C may be used for orientation. Note the characteristic drainage pattern. Compare with Figure 65.

several ephemeral streams that can cause sharp rises in the ground water levels in the soil mantle during winter storms. It is quite common to note ground water seepage on exposed bedrock in the headwall even during the summer. Figure 52 shows a block diagram that illustrates the features of Type I sites. This area was taken from the upper Smith River in Oregon as shown on the topographic map in Figure 53.

Figure 52. A block diagram of Type I sites, the steep, highly dissected terrain with sandstone bedrock where debris avalanches are the most common kind of slope failure. This diagram was made from the topographic map of the drainage basin outlined in Figure 53. The mouth of the basin is at point A, and two high points are identified as points B and C. The vertical scale of the block diagram is greatly exaggerated. Note the steep headwall areas below point B and above point A. Compare with Figure 64.

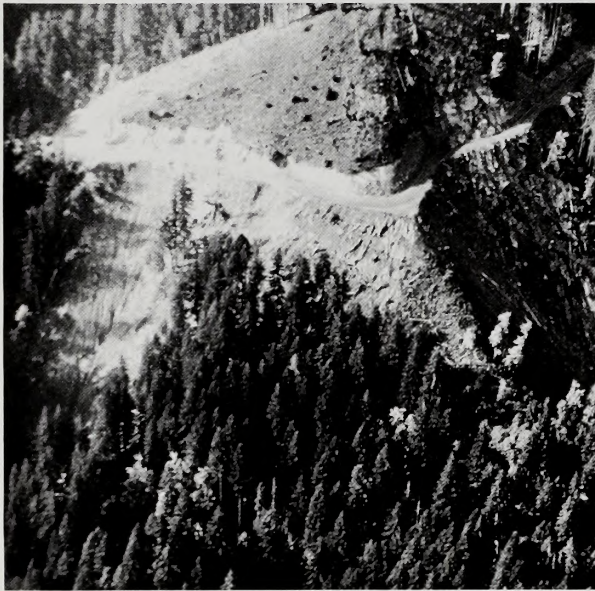
Figure 54. Two steep headwalls where material sidecast from roads has caused debris avalanches.

sidecast. The probability is high for even minimum amounts of sidecast to overload slopes with marginal stability and to cause these slopes to fail (Figures 54 and 55). Observers often comment on the stability of full bench roads that were built through headwalls without realizing that debris avalanches may have occurred during construction before any traffic moved over the road. Figures 56 and 57 show the potential for damage to life and property from the fast moving and very destructive debris avalanche and debris flow.

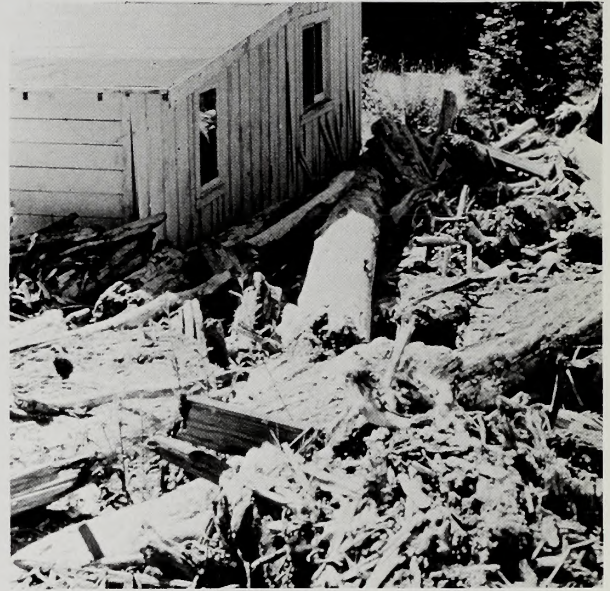
Figure 56. The result of a debris avalanche from a road fill in a headwall in sandstone material.

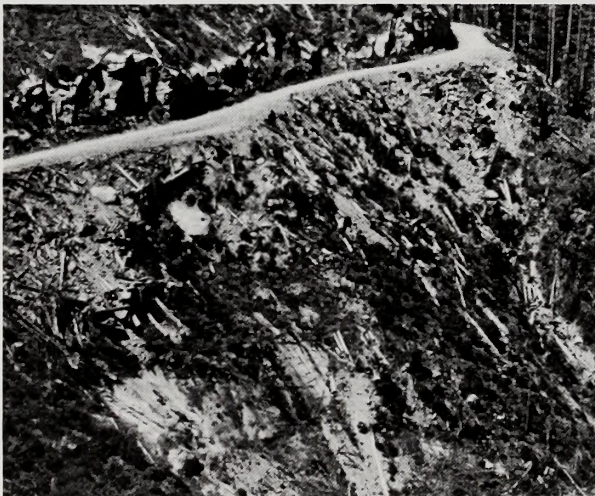
Figure 55. A view of several headwalls with extremely steep slopes and shallow soils.

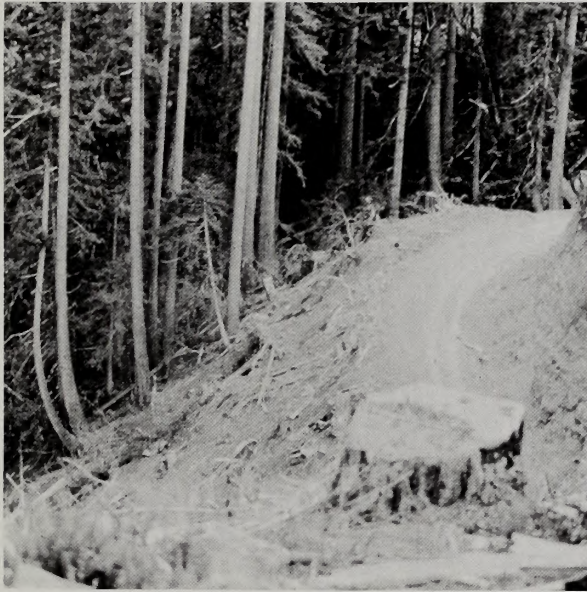
Figure 58. Pistol-butted trees may be used as an indicator of active soil movement when the trees were young.

Pistol-butted Trees (Figure 58). These trees were tipped downslope while small as a result of sliding soil or debris, or as a result of active soil creep. As the tree grew, the top regained a vertical posture. Pistol-butted trees are a good indicator of slope instability for areas where rain is the major component of winter precipitation, but it should be kept in mind that deep, heavy snowpacks at high elevations, such as the High Cascades, may also cause this same deformation.

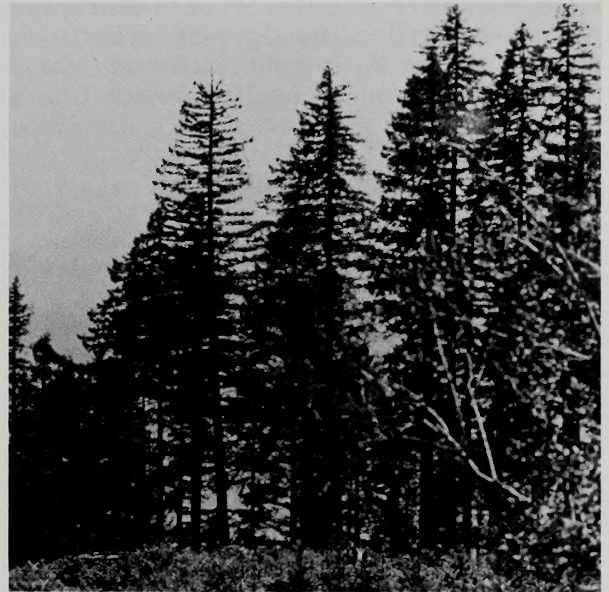
Figure 59. Tipped trees have a sharp angle in their stem.

Tipped Trees (Figure 59). These trees have a sharp angle in the stem. This indicates that the

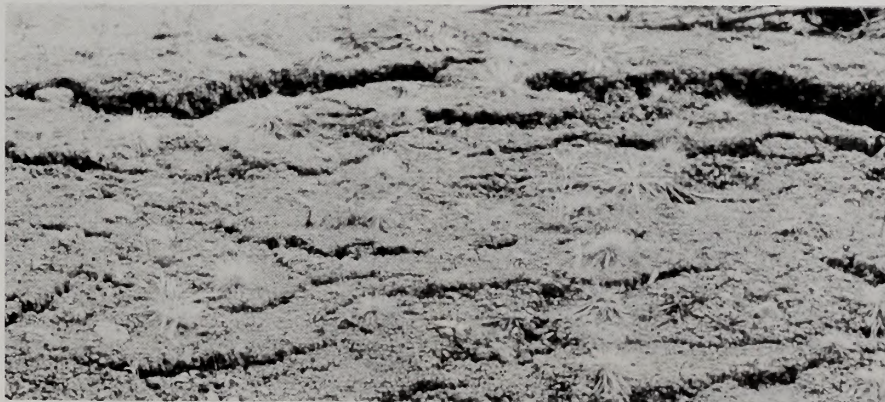
Figure 60. Tension cracks indicate an actively failing slope.

Tension Cracks (Figure 60). Soil creep builds up stresses in the soil mantle which are sometimes relieved by tension cracks. These features may sometimes be hidden by vegetation but they definitely indicate active soil movement.

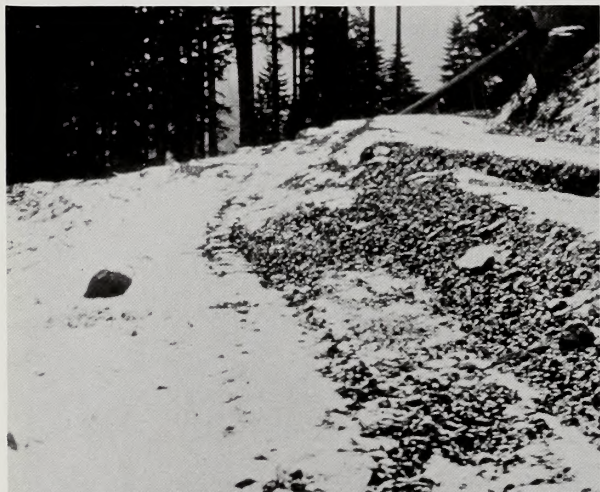
Figure 61. A disposal site for endhaunted material was located to the left of, and below, the road. Note the cracked and sunken grade.

Select Safe Disposal Sites. Disposal sites for endhaunted material should be chosen with care to avoid overloading a natural bench or spur ridge and causing slope failure (Figure 61). The closest safe disposal site may be a long distance from the construction site but the additional hauling costs must be weighed against the damage caused by failure of a closer disposal site with a higher probability of failure.

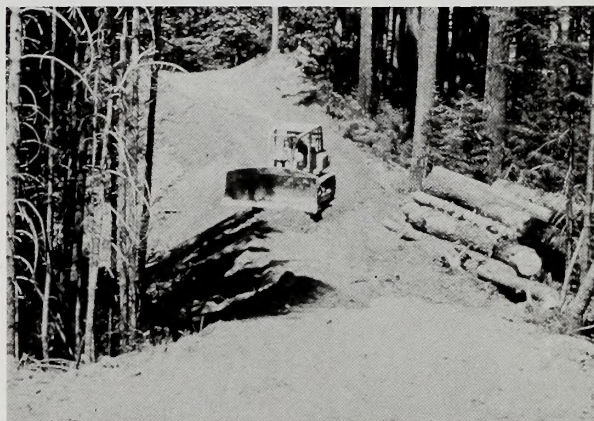
Figure 62. Endhaunted material may be compacted on narrow ridges.

Fill Saddles. Narrow saddles may be used to hold endhaunted material by first excavating narrow bench roads below, and on each side of the saddle. The saddle may then be flattened and the loose material that rolls downslope will be caught by the benches. Endhaunted material may be compacted on the flattened ridge to build up the grade (Figures 62 and 63).

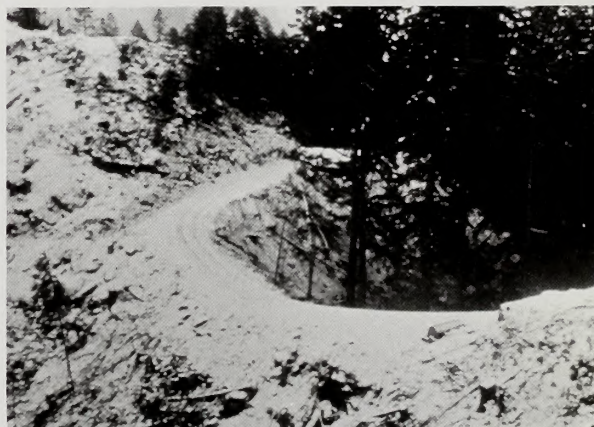
Figure 63. This ridge road has remained stable through several winters.

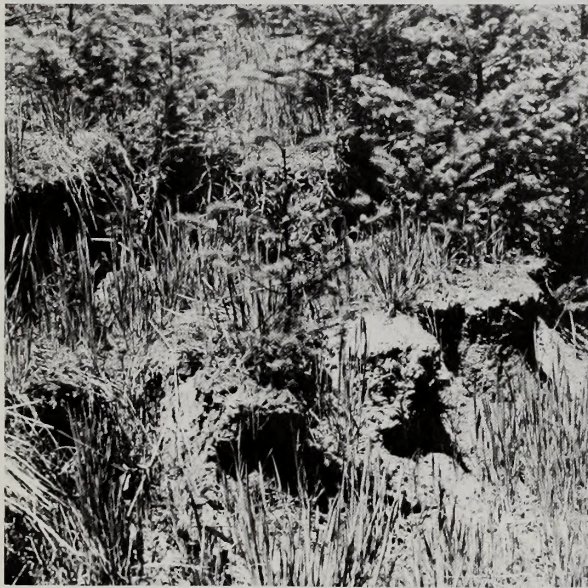
Figure 66. Cat steps, or small scarps, result from slope failures.

Vegetative indicators of unstable portions of the landscape include mature trees that tip or lean as a result of minor earthflow or soil creep on the steeper slopes. Tipped or leaning trees may also be found on poorly drained soils adjacent to the stream channels. Actively moving slopes may show tension cracks or cat steps (Figure 66), particularly on the steeper slopes.

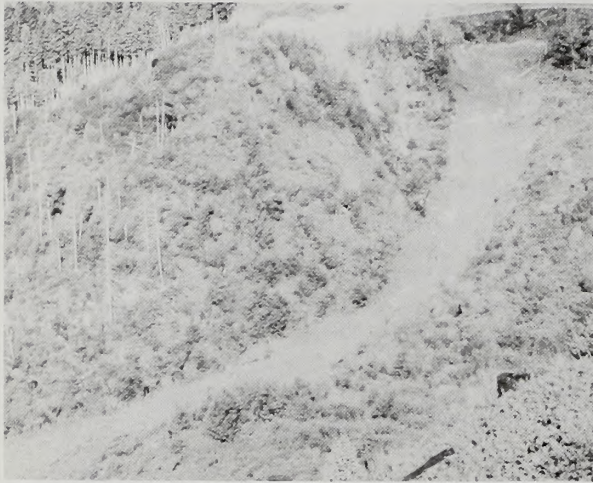
Figure 67. Failures of saturated, clayey fills may begin as a slump, then continue as a mudflow.

Special Attention to Fills. Fills of clayey material over steep stream crossings may fail if the material is not compacted and ground water saturates the base of the fill. Fill failures in this wet, clayey material on steep slopes tend to move initially as a slump, then may change to a mud flow down the drainage (see Figure 67). To reduce the chance of fill failures, the following alternatives are suggested:
